V3^{By}mis
More with Less

Overview

The V3 implant system is the outcome of an exceptionally high-level R&D process that has resulted in an implant that is simple, easy-to-use and offers enhanced functionality and performance. The V3 conical connection implant features built-in design characteristics which may provide biological benefits for hard and soft tissues and promote esthetic results.

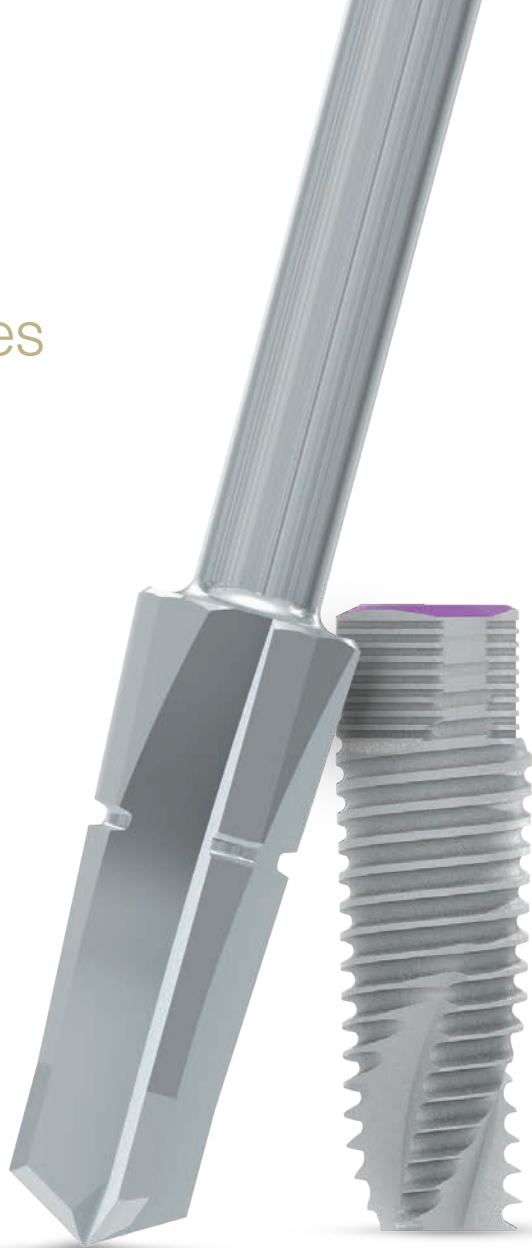
V3 Features

Each and every V3 implant comes with a sterile, single-use final drill.

The compression-free gaps around the coronal area of the V3 were engineered to provide a reservoir for blood pooling and the formation of blood clots. These conditions are both required for optimum implant integration and bone growth.

The gaps around the sides of the implant neck were designed to result in an open, compression-free zone. Crestal bone loss may be minimized by reducing stress in the cortical bone.

The triangular shape at the V3 neck was engineered to provide high immediate crestal stability and potential bone preservation. Anchorage may be achieved at three points without compromising crestal primary stability.

The V3 implant incorporates the platform-switching design concept. Implants with a platform-switched configuration have been shown to exhibit less bone loss when compared to non-platform-switched implants, which may lead to soft tissue preservation and growth.

The 12° conical connection was engineered to create an ultimate seal and ideal connection between the implant and abutment with built-in platform switching, reducing micro-movements.

Micro-rings on the neck of the implant are designed to facilitate an increase in bone to implant contact (BIC). This design concept has been reported to be associated with less crestal bone loss when compared with other implant design features.

The surface roughness and micro-morphology is a result of sandblasting and acid etching. This proven MIS surface technology leads to a high level of cleanliness, which leads to effective osseointegration. This is one of the key factors which contribute to long-lasting clinical success.

The flat apex is designed to allow good grip into bone, especially in immediate placement procedures.

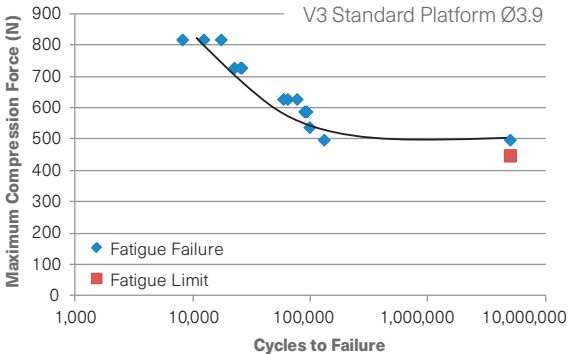
Fatigue Testing

Fatigue testing is critical for establishing the ultimate strength and reliability of an implant-abutment assembly in accordance with ISO 14801:2007 standards. The testing process specifies a method for determining the fatigue strength and behavior of these devices in vitro. The tests simulate the functional loading of the implant body under “worse case” loading conditions. V3 test results exceeded expectations.

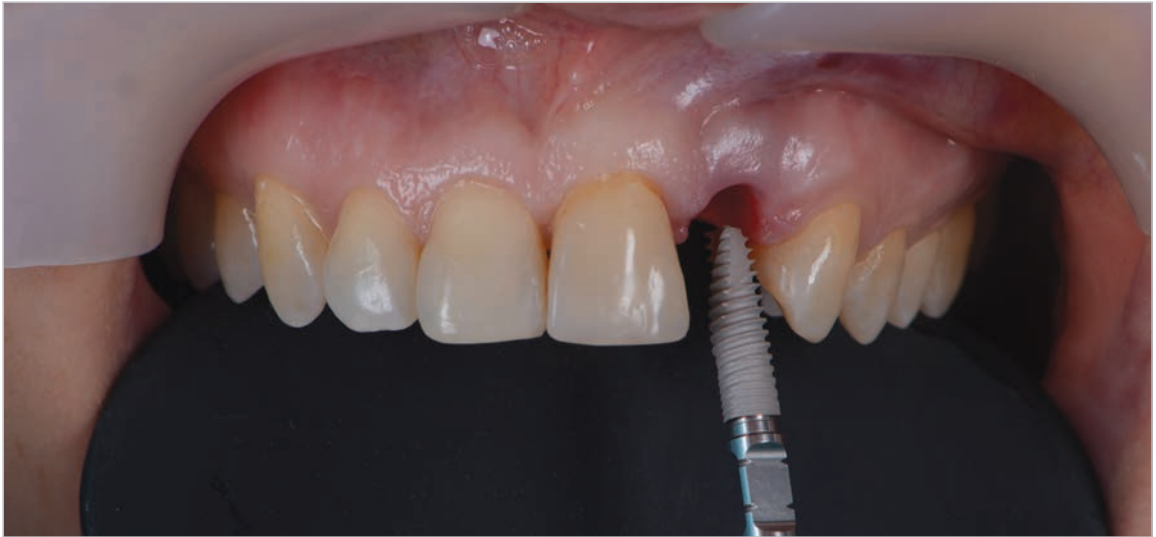
Fig. 3 V3 Implant placement

The patient came to Dentcof-Timisoara-Romania for a check-up. We found at the tomography an internal root resorption on tooth number 22. We decided to replace the tooth with an implant. Using the alveolar model technique, we extracted #22 with minimal invasive instruments. Placed a 3,9x13mm V3 implant. We grafted with connective tissue graft and Bio-Oss and finished the surgical procedure with immediate loading.

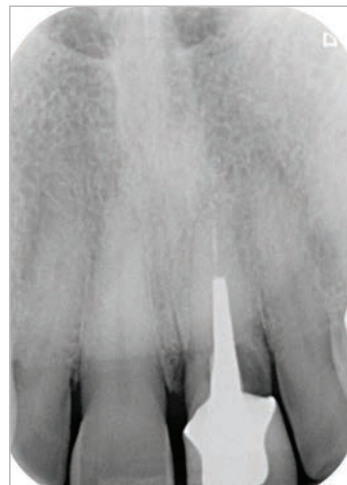
Fig. 2 Radiograph of tooth #21 showing a loss of radicular integrity.

A 48 year-old male patient attended because of recurrent decementation of his prosthetic crown on tooth #21. Clinical and radiographic examination revealed that the loss of integrity of the root is what impaired stabilizing the prosthetic crown. Extraction and subsequent implant therapy were indicated.

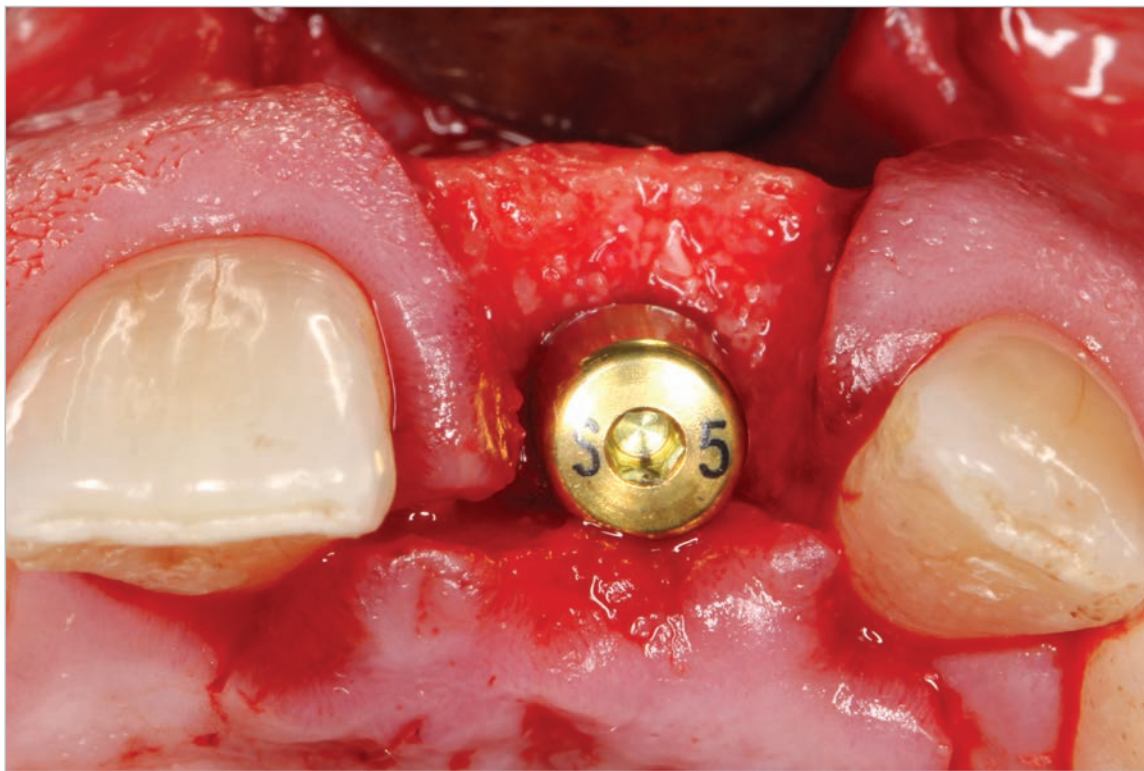
Fig. 5 Occlusal view of the V3 implant with its healing abutment. Note the width of the achieved vestibular bone lamella.

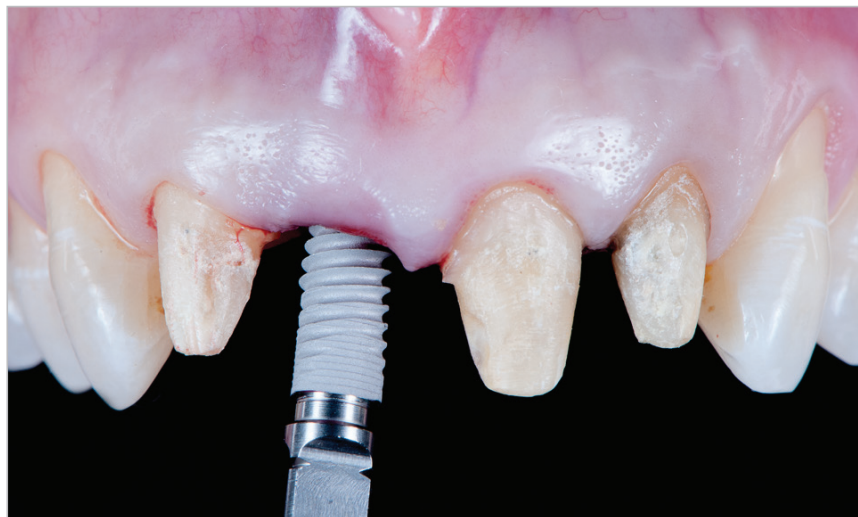
Fig. 7 V3 implant placement.
